*Determining the origin of localised subsidence  
features in the Kawerau Geothermal Field,  
Bay of Plenty, New Zealand*

A thesis submitted in partial fulfilment of the requirements for the degree

Masters of Science in Engineering Geology

University of Canterbury

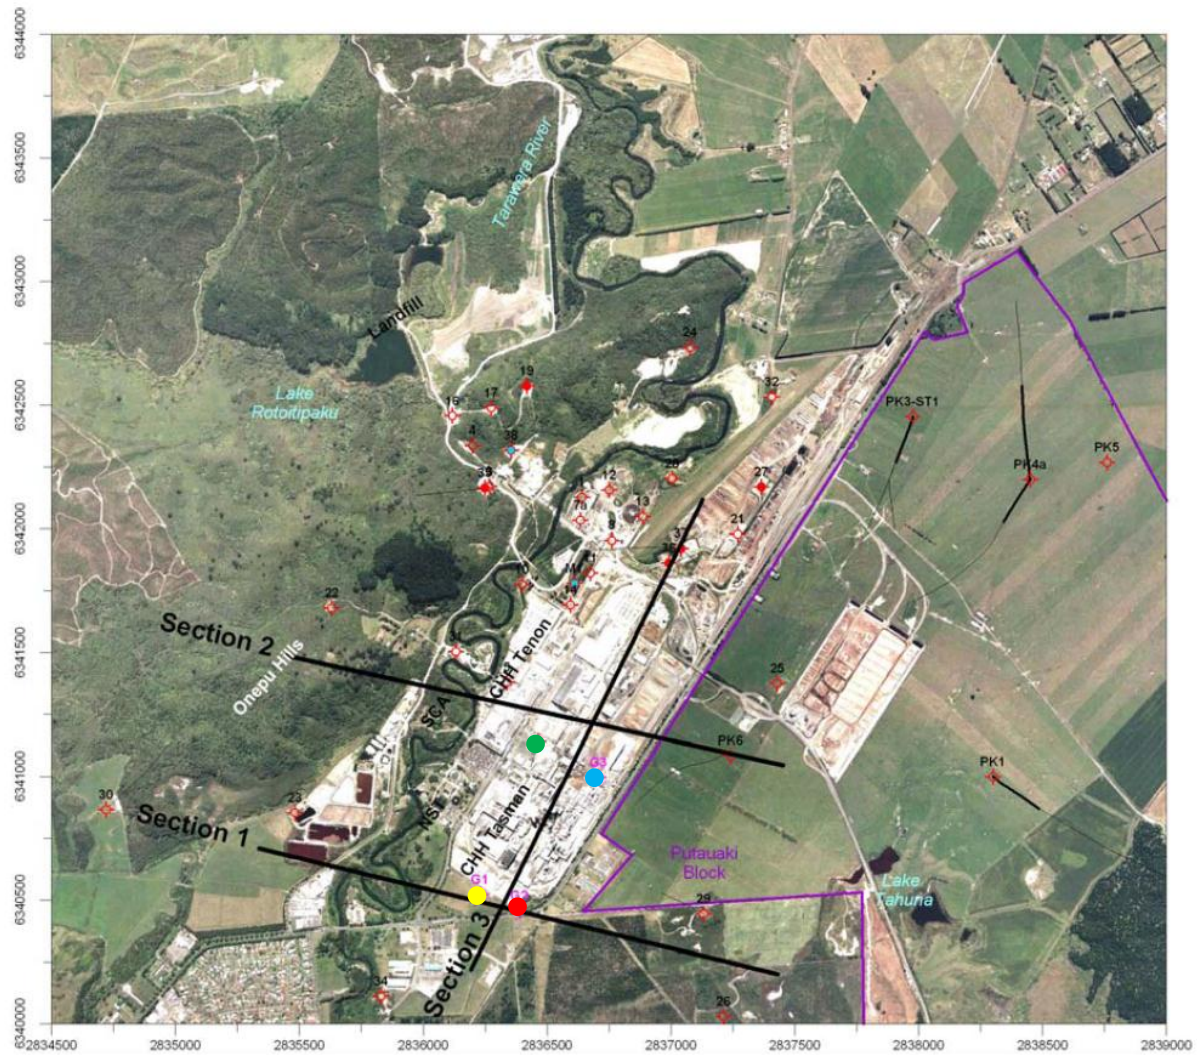
Figure 8: Location of geotechnical drill holes G1 (yellow dot), G2 (red dot), G3 (blue dot), and KA41 (green dot) (SKM, 2005).

Depths of lithologic units have been taken from geotechnical drill hole G2 (Figure 8) and description of units is primarily from SKM (2005) with any extra information as referenced. Drilling information was not available for all units.

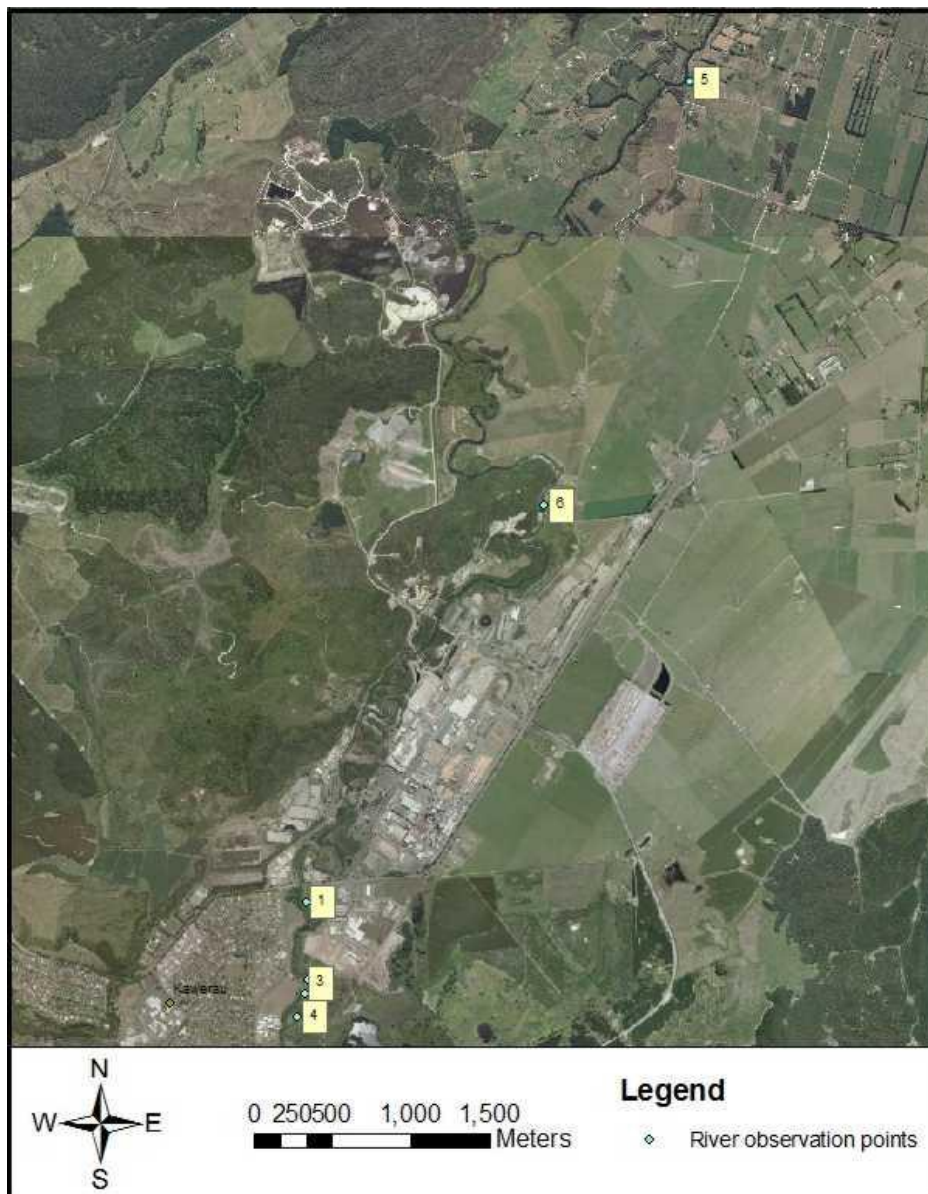
Figure 13: Map showing location of Tarawera River descriptions

Site	River width (m)	River depth (m)	Description
1	15-20	Up to 1.5	Swift and clean, low sediment load, bottom covered in pumice and rocks up to 200 mm diameter. Banks medium sand to pebble sized grains. Stream entering river at this site looks very scoured out, very loose, friable banks.
2	20	1.5-2.0	Swift and clean, low sediment load. Silt to pebble base with some rocks up to 200 mm diameter. Outcrop on opposite side of river ~6 m high – grey, looks fine grained and similar grain size throughout.
3	15-20	Up to 2.0	Other side of river meander from Site 2. Swift, clear, very silty bottom. Soft, friable banks.
4	15-20	unknown	Swift moving, silty bottom, some stones up to 40 mm diameter. Bank on opposite side ~4 m high, easily eroded and very friable, looks like ash and lapilli layers, actively collapsing in to the river.
5	~10	unknown	River meandering, slower moving than earlier sites, water is black and dirty. River banks ~4 m high, reddish colour with angular rocks up to 100 mm diameter, moderately friable. Some armour stone around 100 m downstream suggesting site is easily erodible. Site is a washout, this shows ground is loose and easily erodible in flooding events.

6	~20	1-1.50	Swift moving, relatively clear water. Bottom very silty and has the appearance of ash with rocks up to 100 mm. River banks soft, friable light grey ash, some reddish horizons and weathering at top. On west side of river bank approximately 1.5-2 m high, bank on east side approximately 6m high.

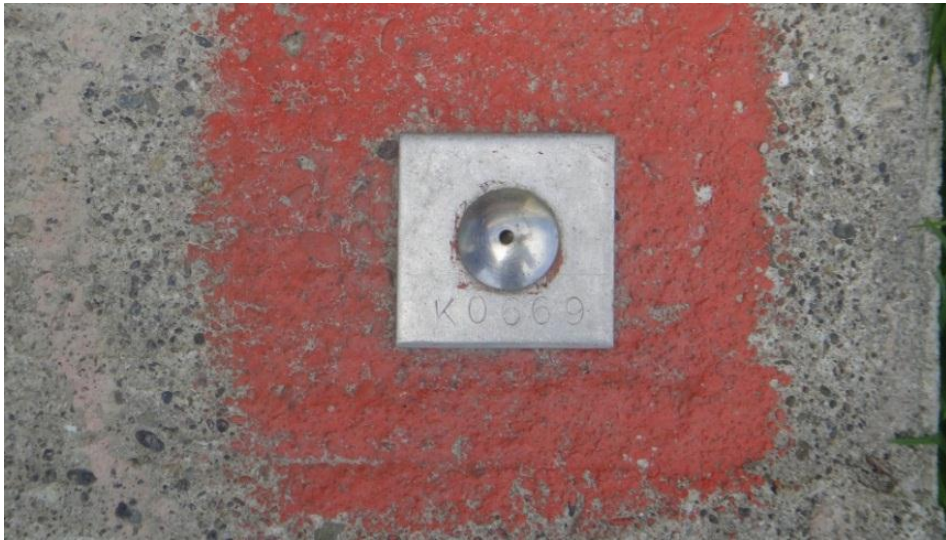
Figure 18: Benchmark number K0669 on the concrete base of a pipe support

Benchmarks installed are 40 mm × M10 stainless domed top coach bolts drilled and glued with Hilti Hit glue (Figure 18). The studs were inserted through a 50×50×3 mm stainless washer with the benchmark name stamped on with red paint around the mark (Energy Surveys, 2009). Figures 19 and 20 show the typical location of benchmarks on structures, Figure 21 shows a benchmark within a concrete box with a steel lid along the side of Onepu Springs Road.

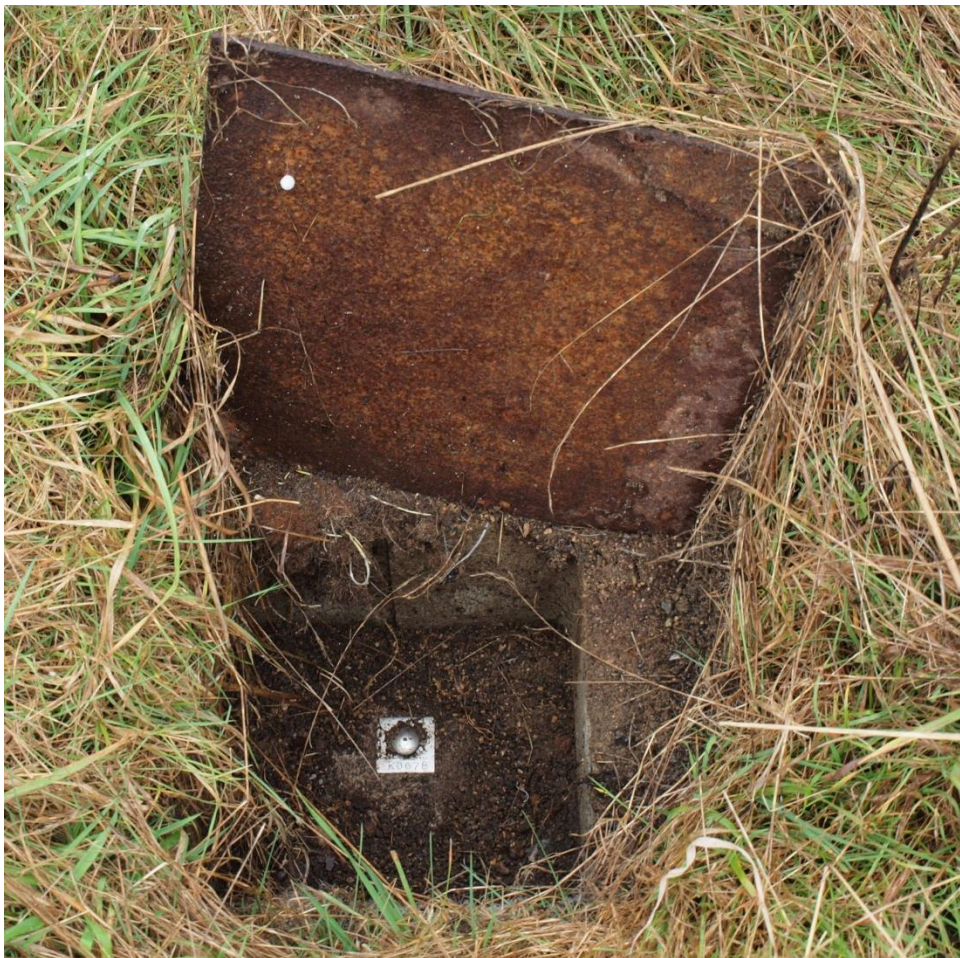
Figure 21: Benchmark along the side of Onepu Springs Road within a concrete box with a steel lid

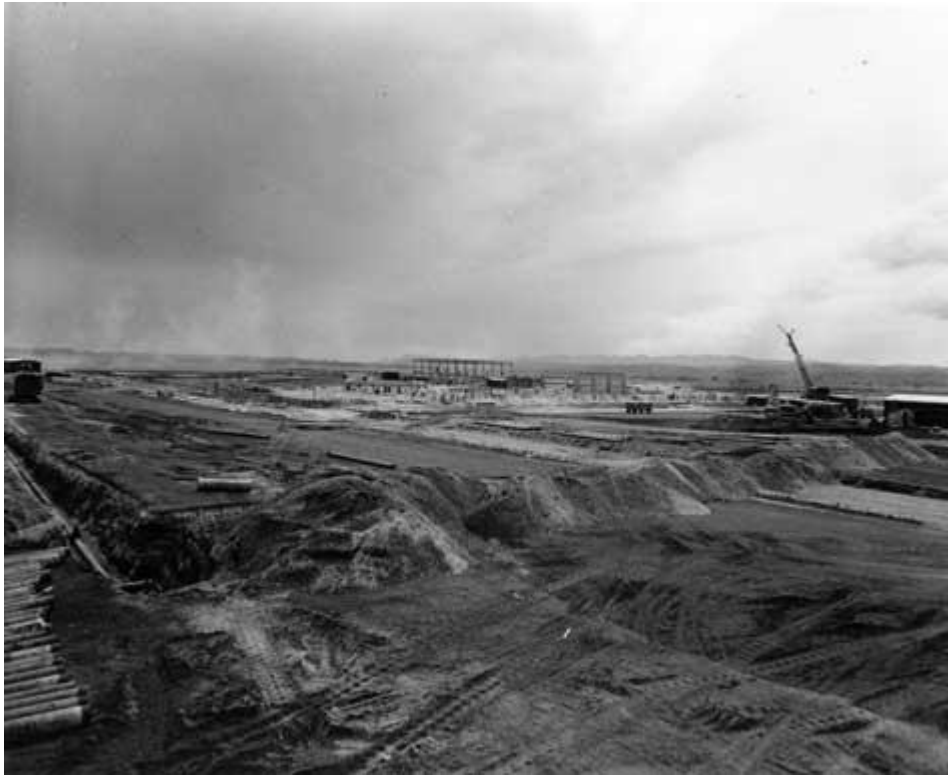
**Figure 33: Photograph of mill under construction, this photograph shows considerable ground disturbance and foundation preparation (9 November 1955)**

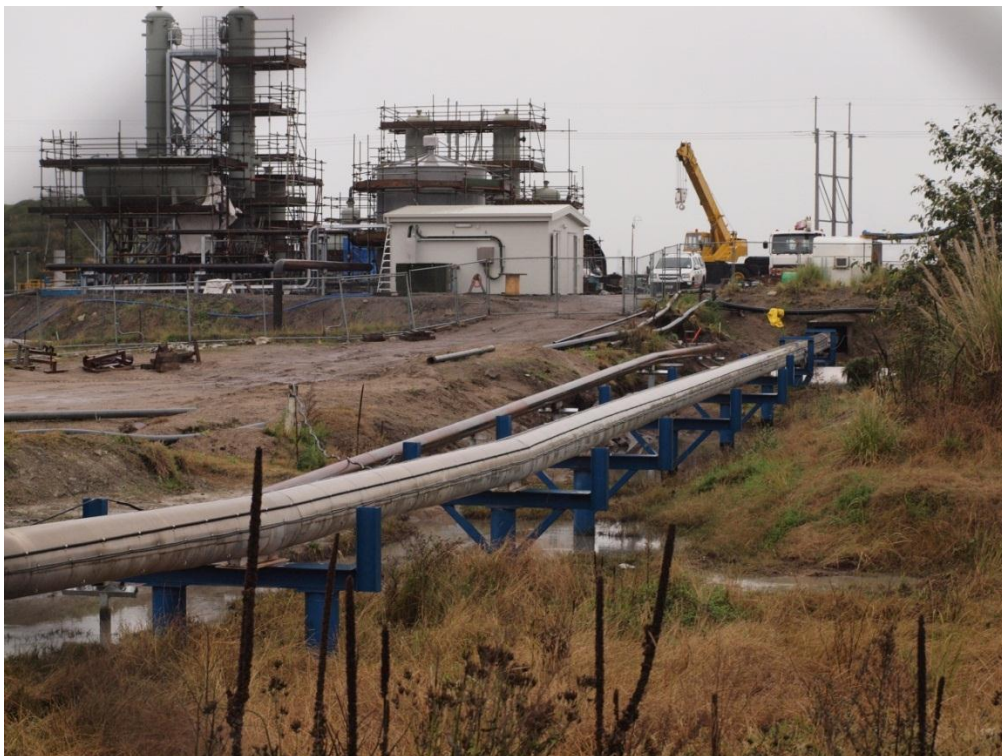
Figure 34: Steam pipeline at Site 1 in drainage channel

During the initial site visit, conditions were very wet with many parts of Site 1 under water, this provided a good opportunity to observe and photograph the site in different conditions (See figures 34 to 37).

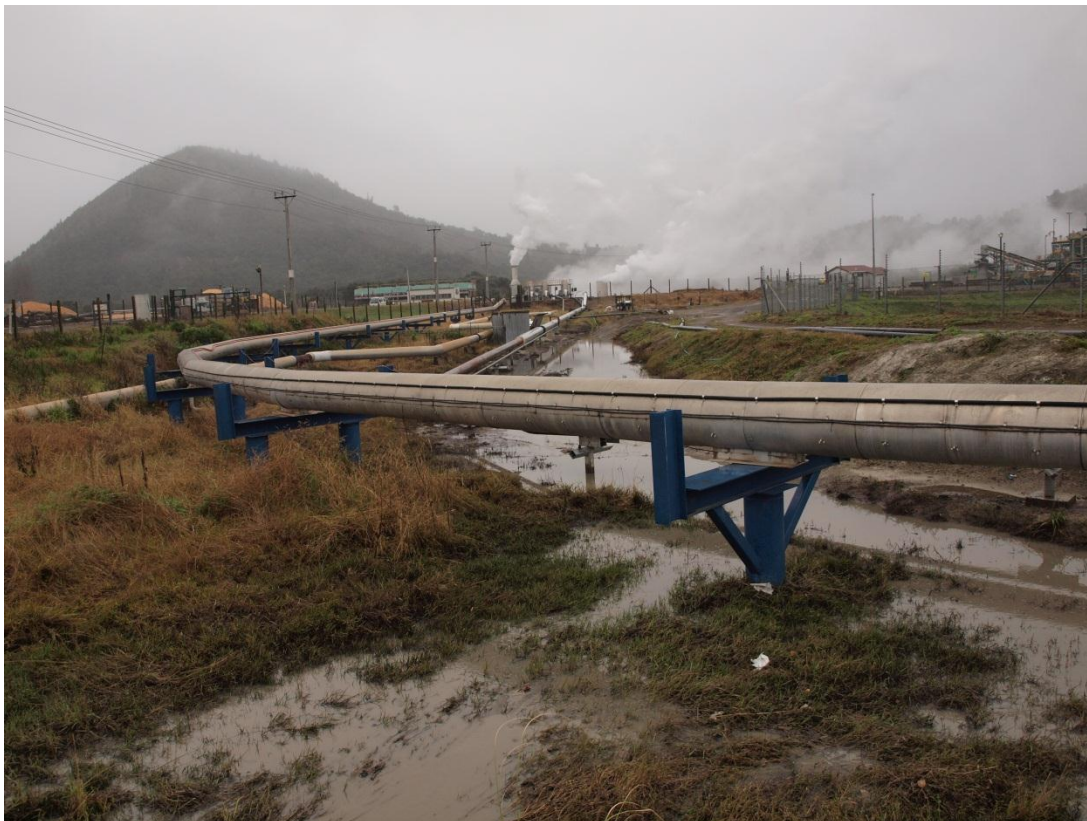
Figure 36: Steam pipelines, fences and power lines at Site 1. Pipeline foundations in soft, saturated ground.

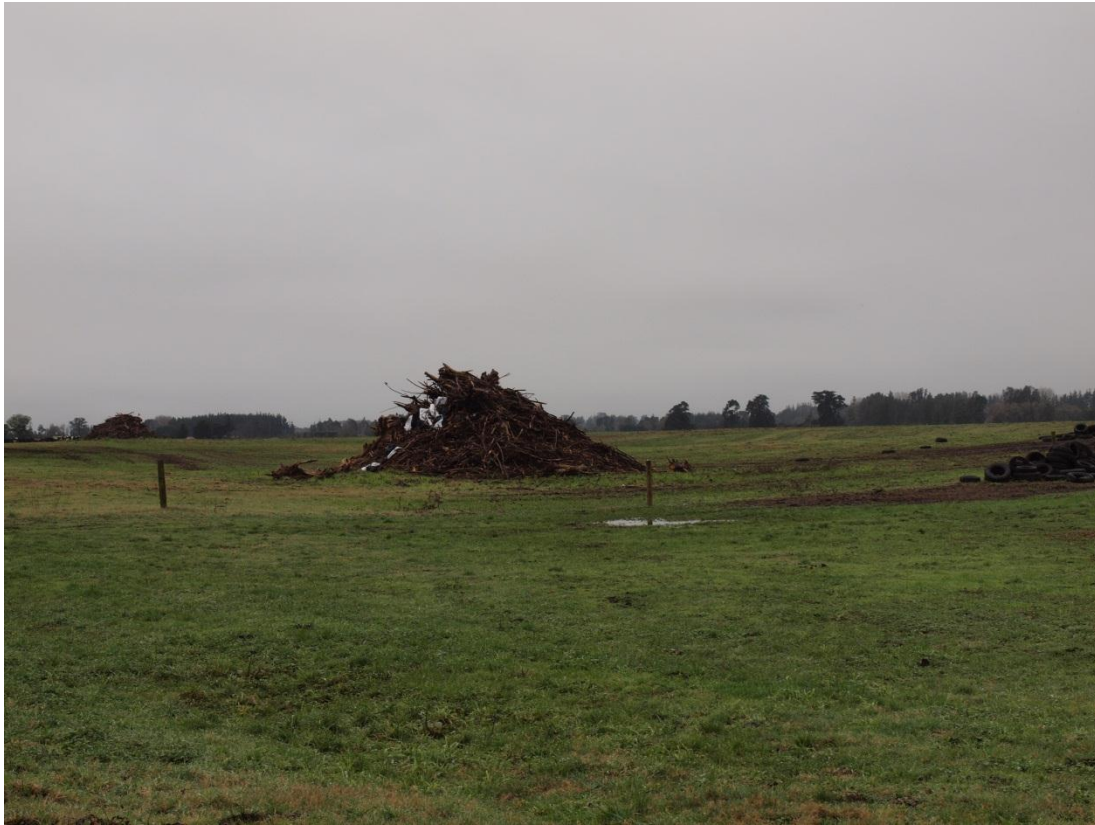
Figure 37: Historic river channel at Site 2

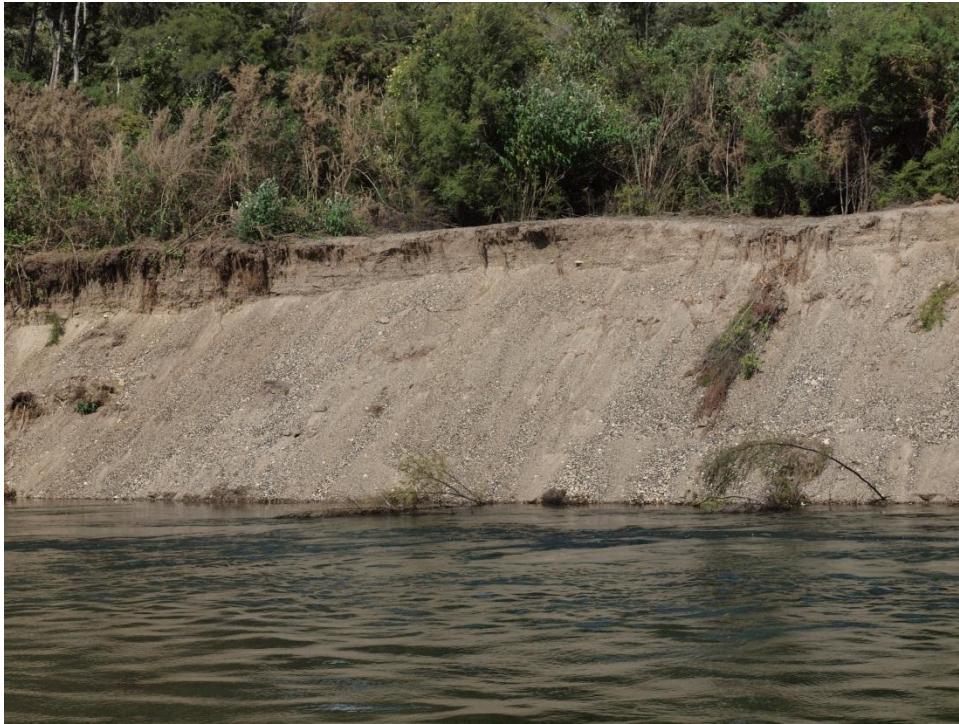
Figure 75: Photograph of the banks of the Tarawera River showing very loose sand eroding easily into the river

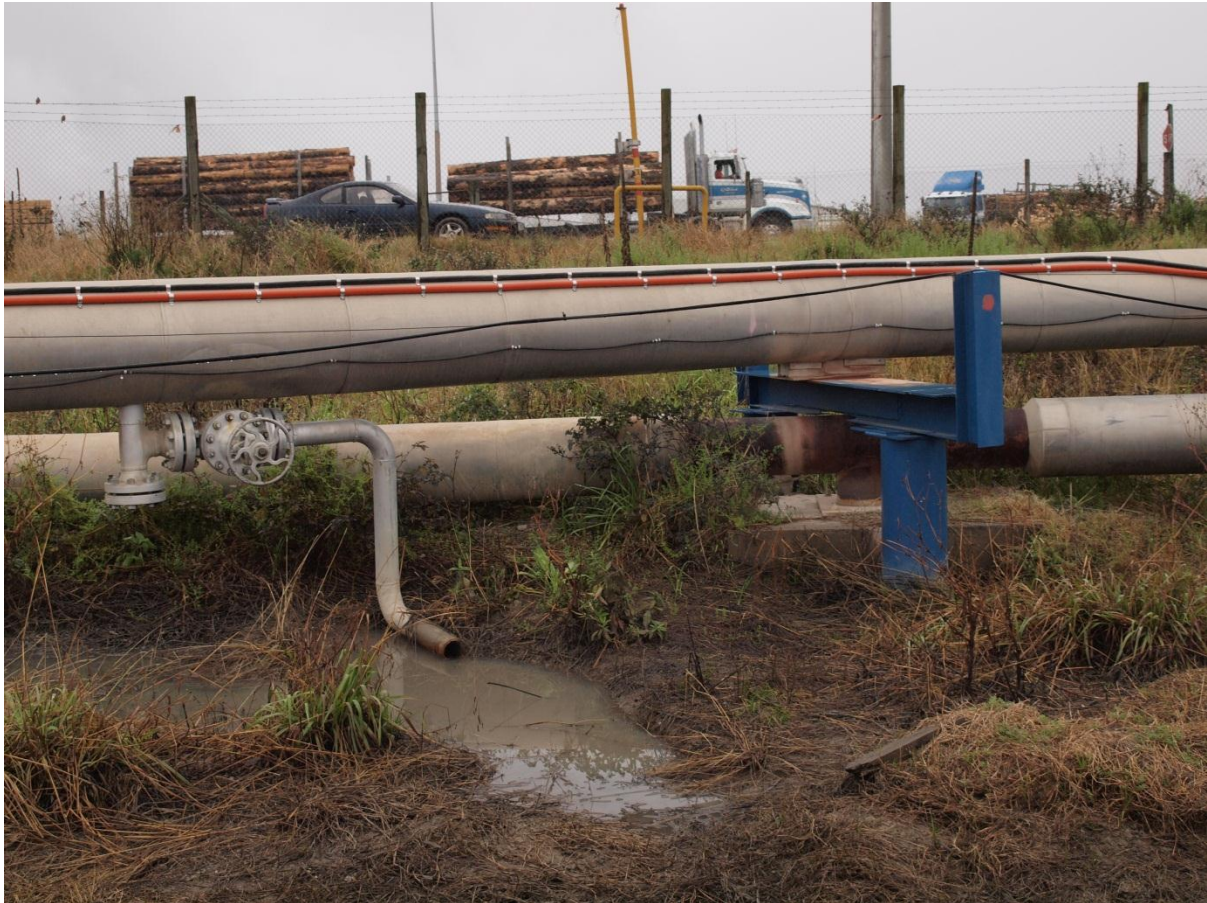
Figure 99: Discharge point on steam pipeline at Site 1

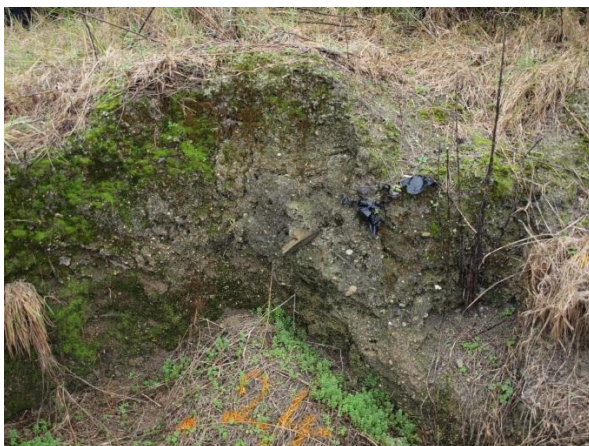
Figure 101: Buried waste material found at Site 1
